# Hawke's Bay orchard surveys after cyclone Gabrielle

Version 1: 10 March 2023

Plant & Food Research, AgFirst, Fruition, NZAPI, Fruitfed, Horticulture,  
Farmlands

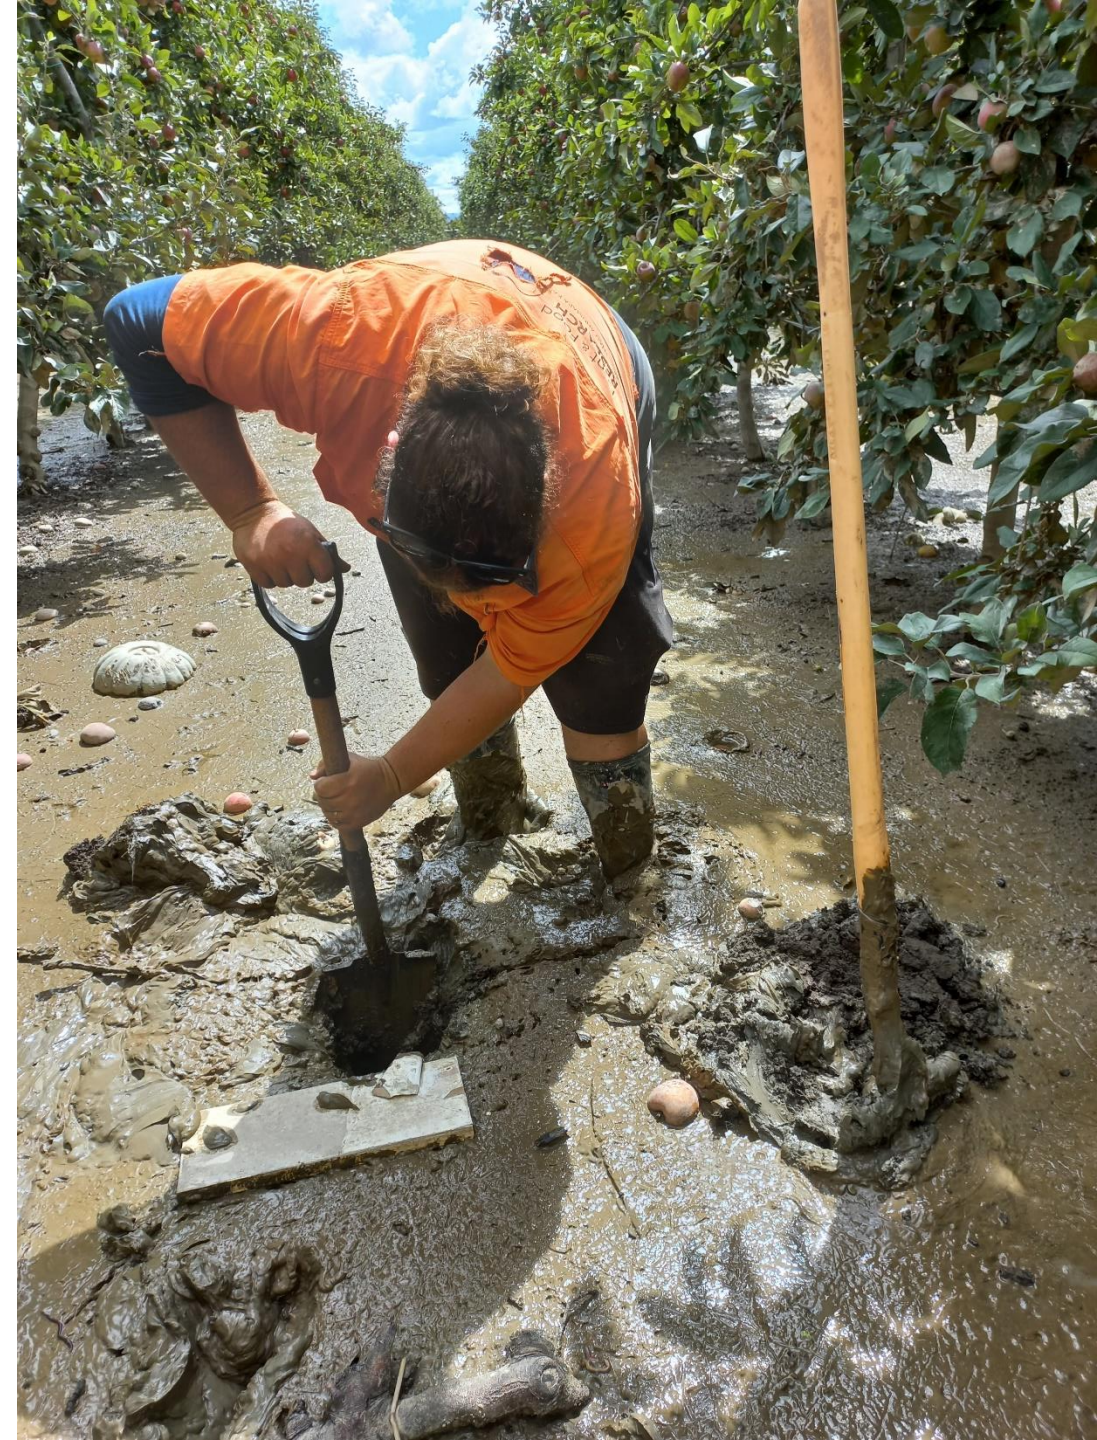
- Surveyed ~30 orchards around the Hastings region 15 and 16 days after the cyclone,

- Height of sediment
- Presence of gleying in the sediment
- Presence of gleying in the original soil
- Depth to water table
- Assess tree health
- Drain health
- Blocks with >30 cm of silt were not assessed

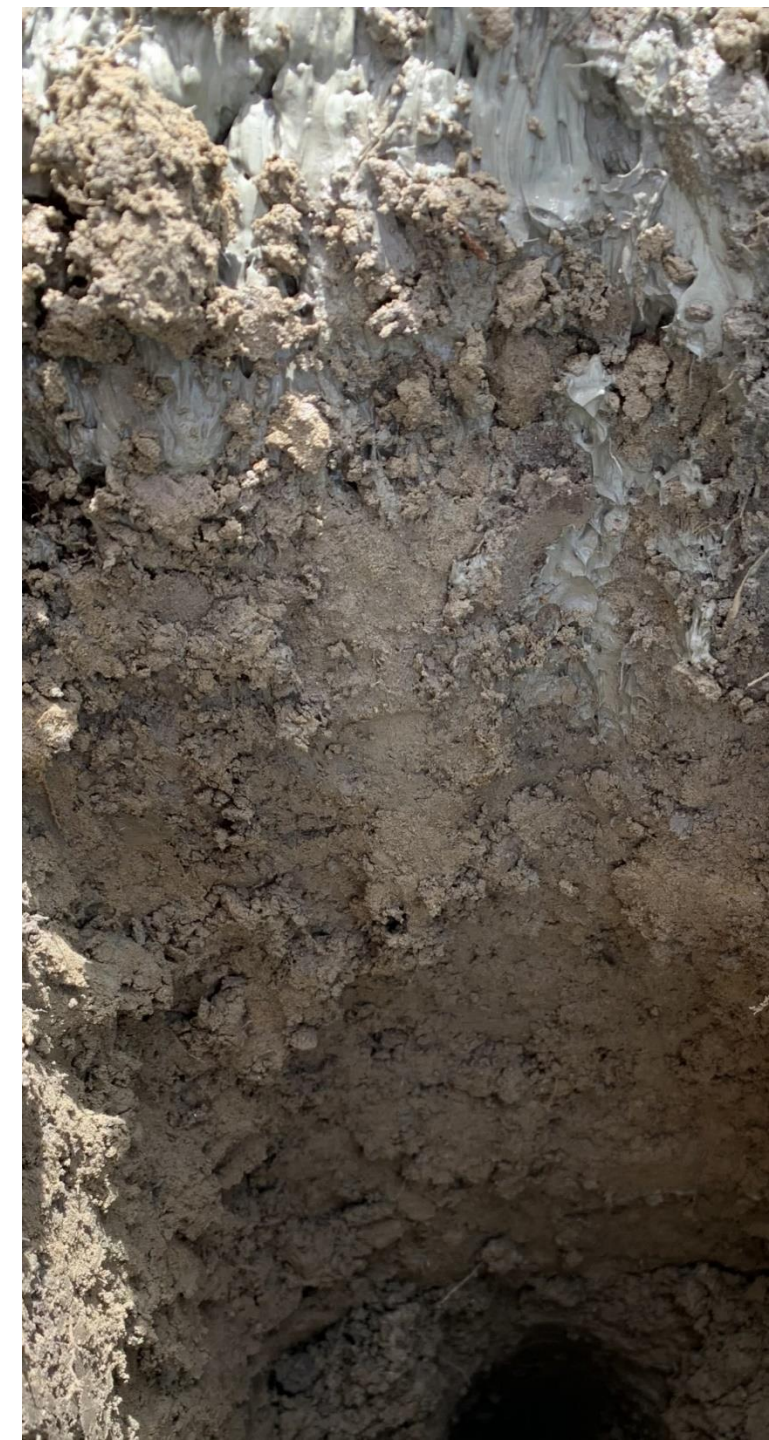
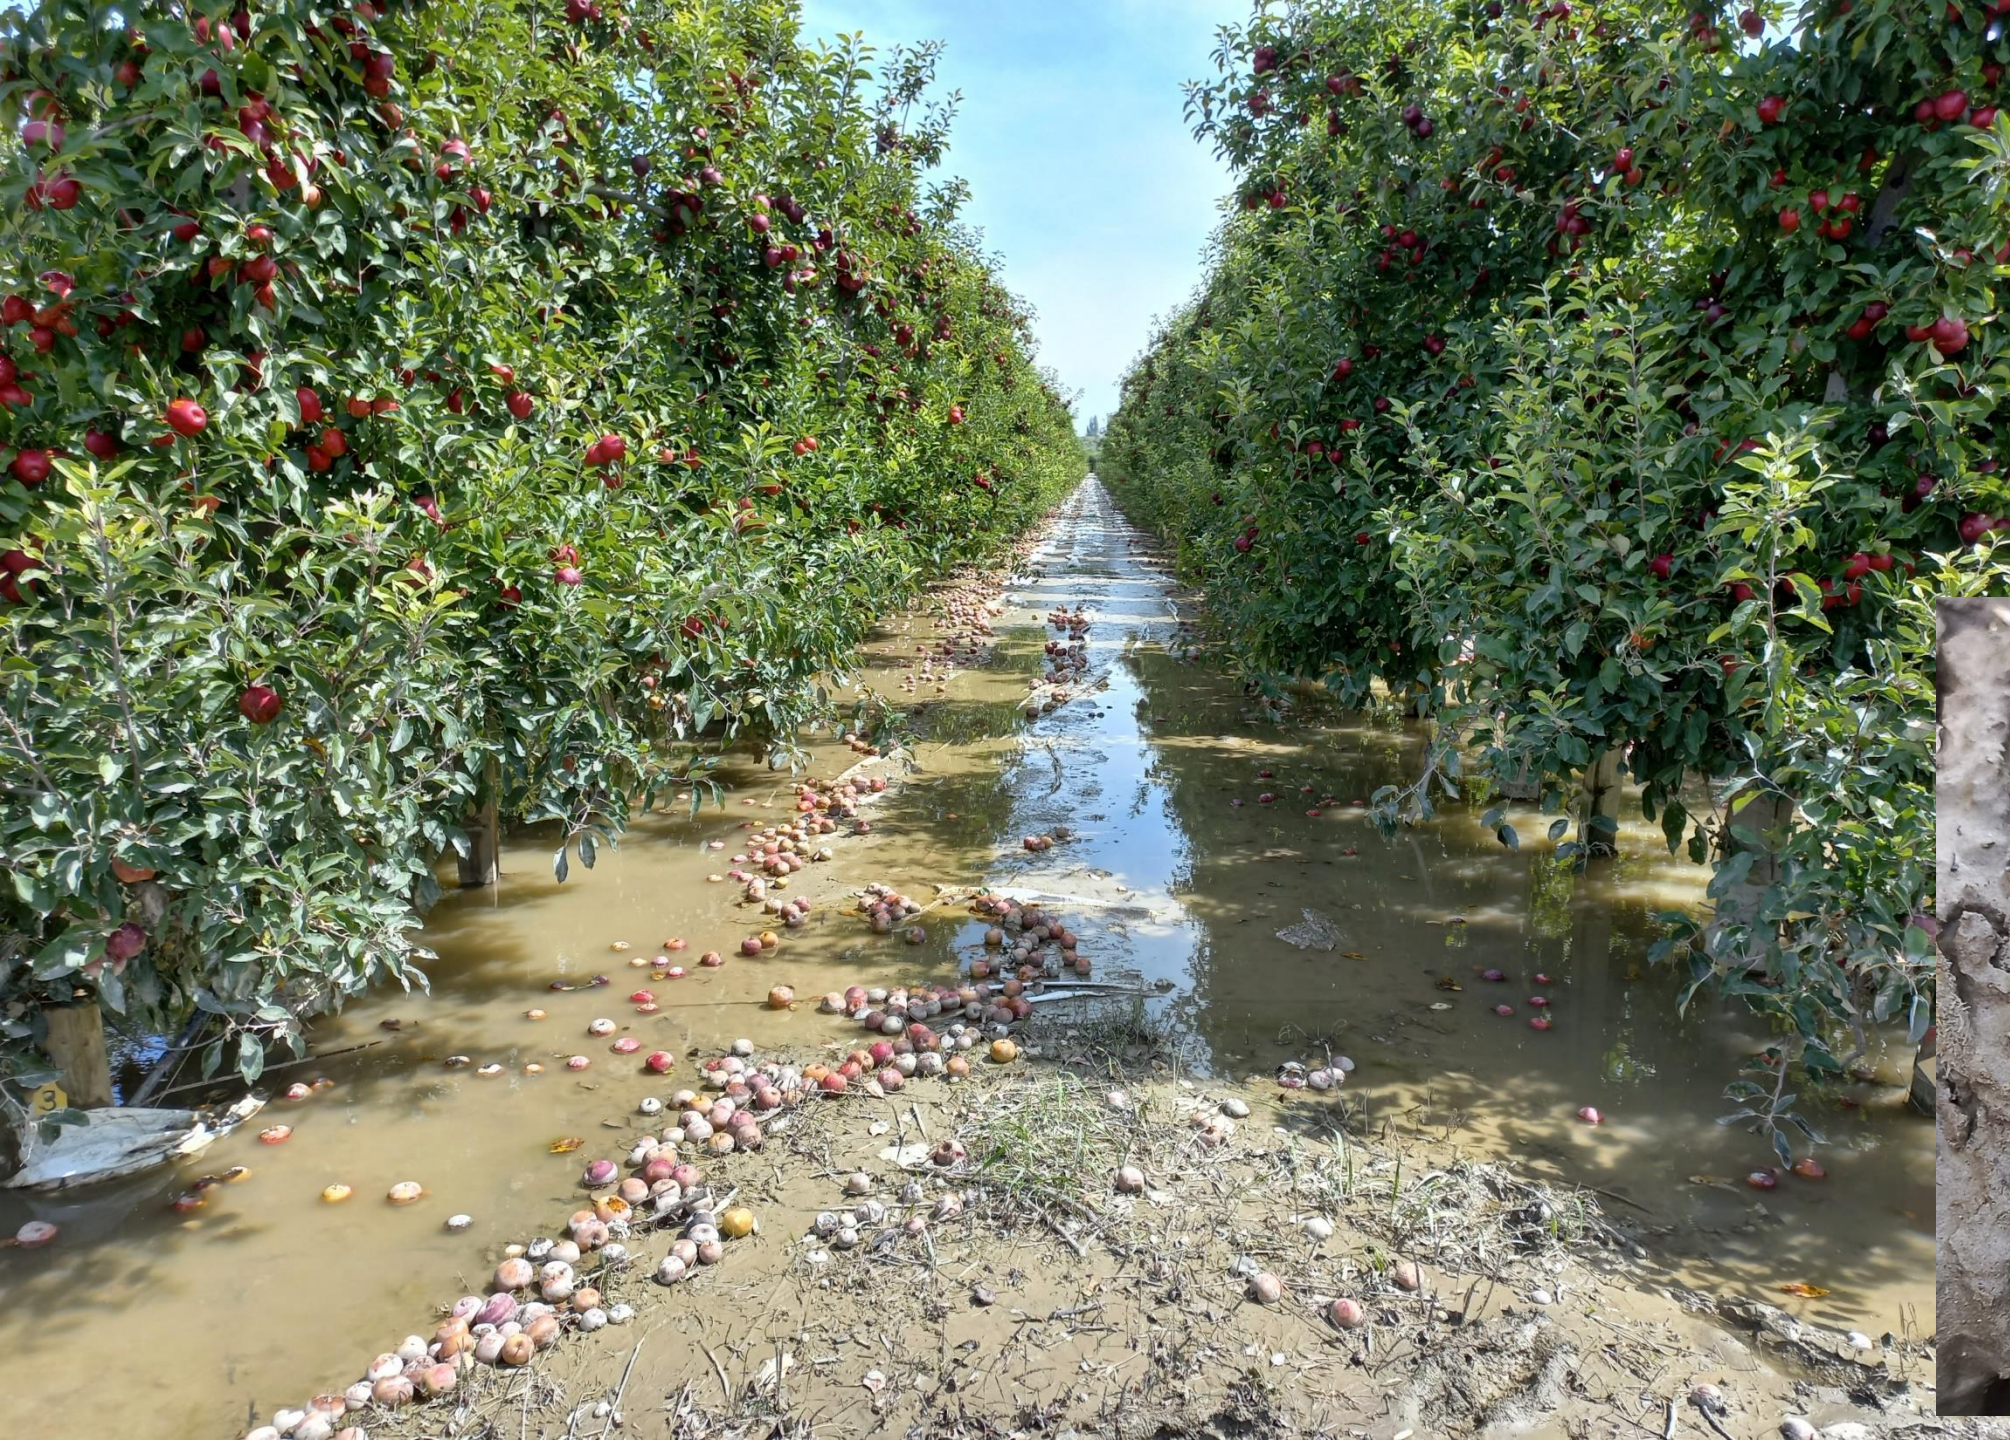
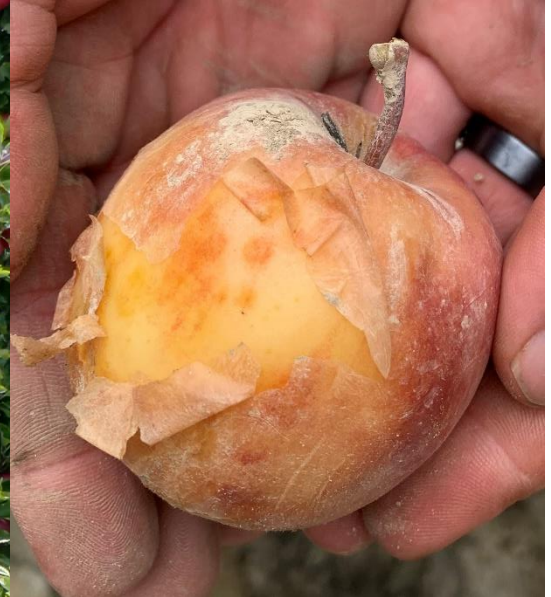
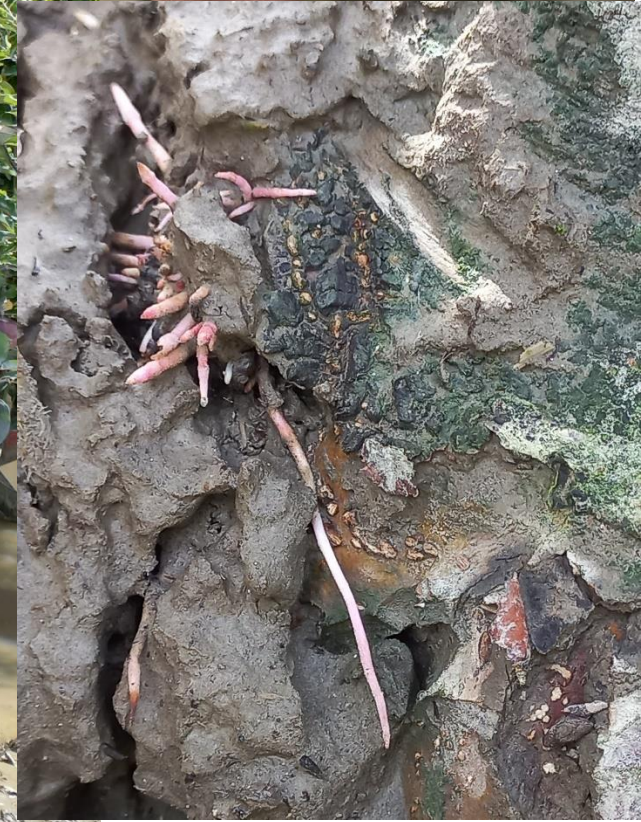
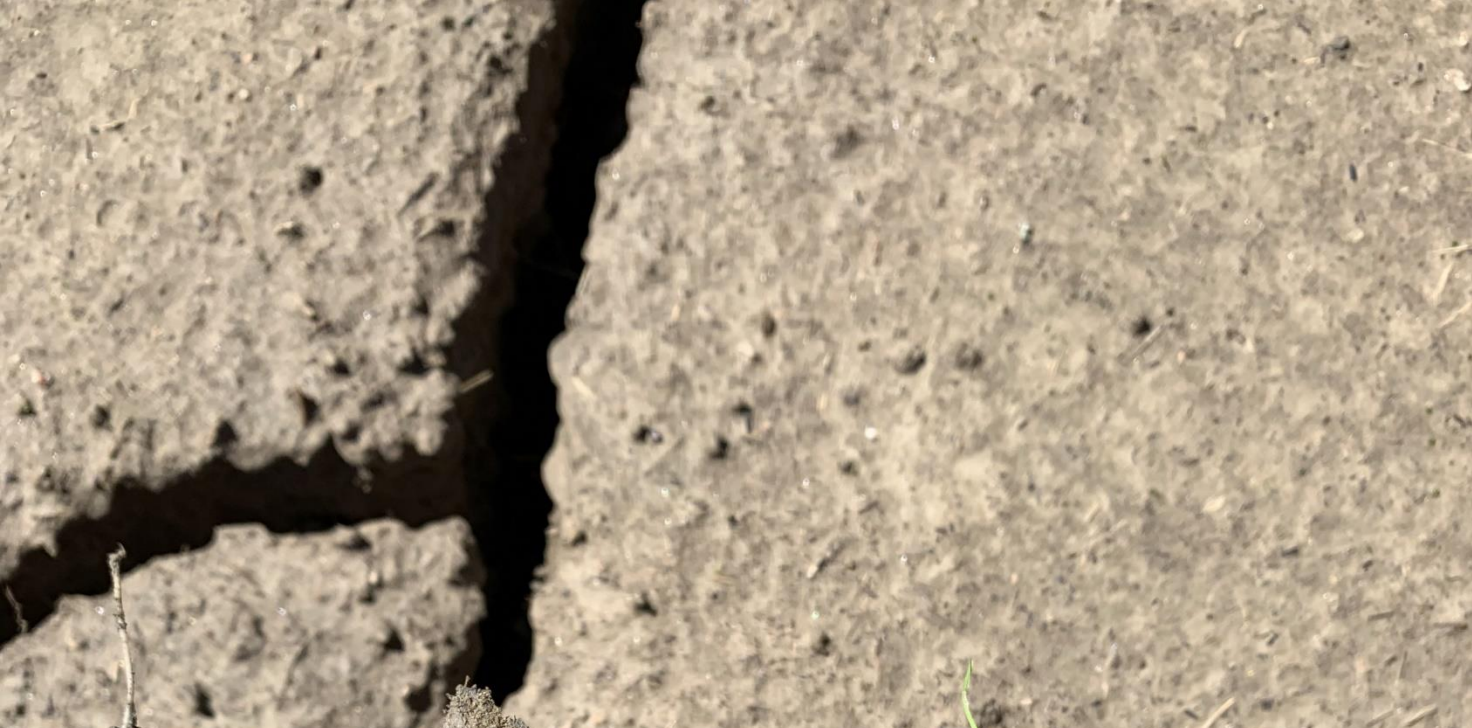
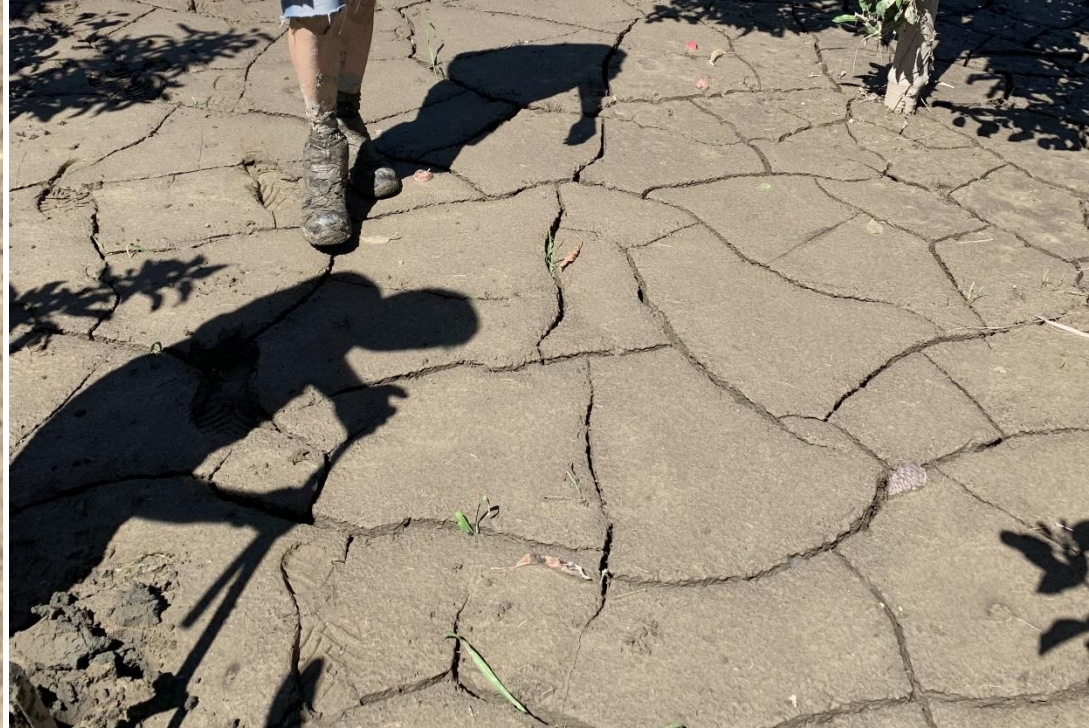
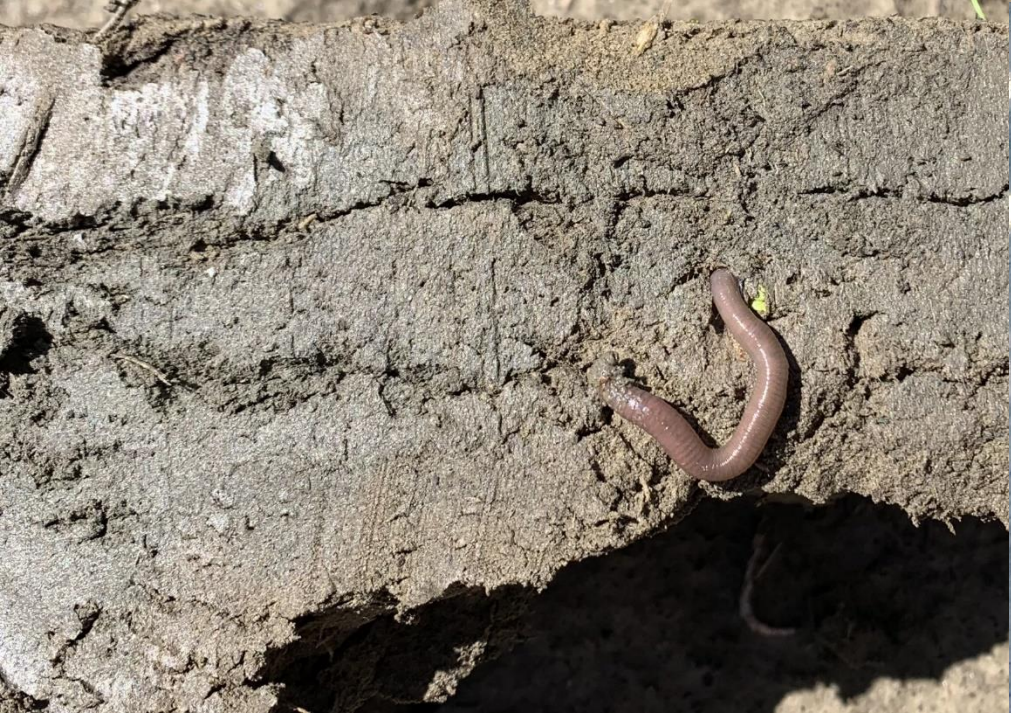
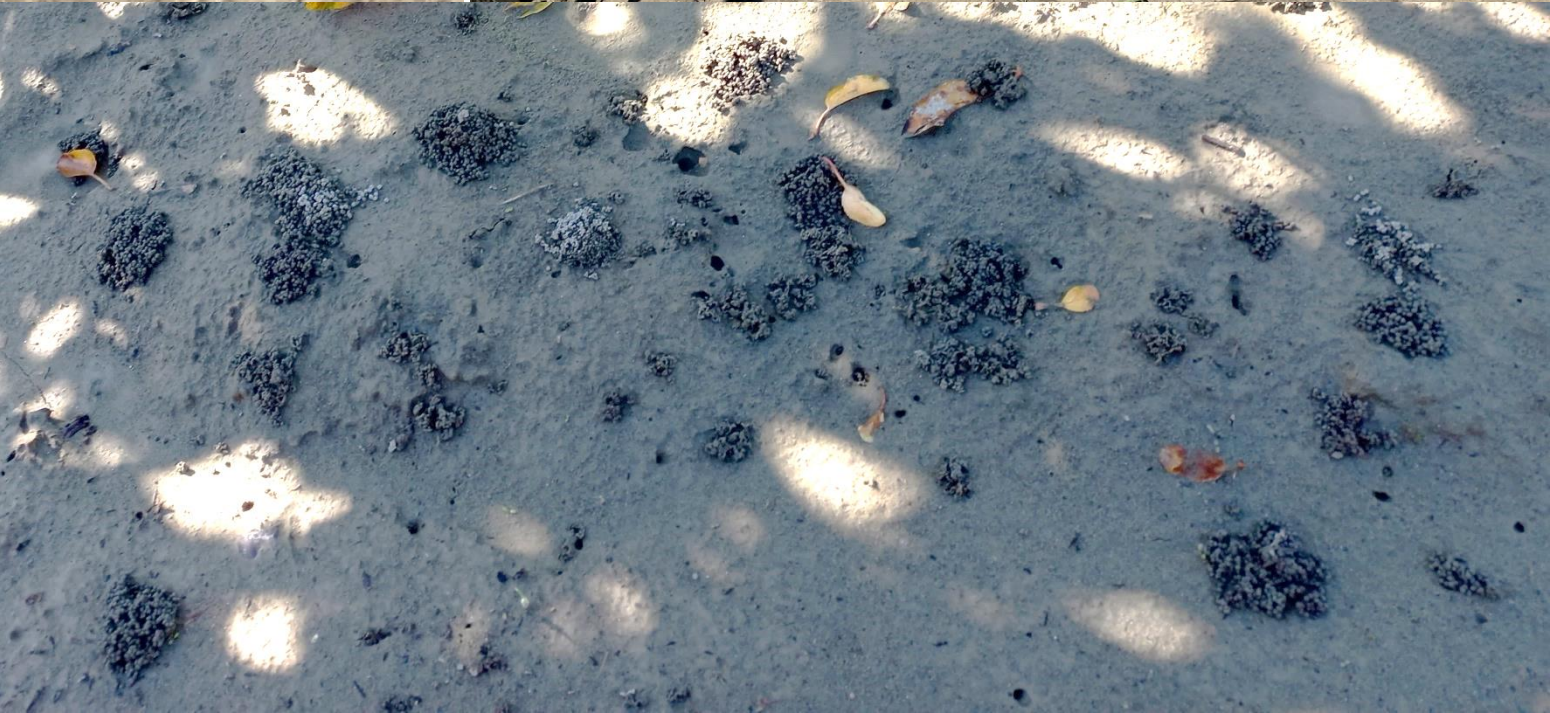
# What we typically found

- A fine textured layer (silt + clay) on the soil surface (10 to >250 mm thick)
- The sediment was still saturated, with consistency ranging from mousse to soup
- The sediment was gleyed, beginning at the original soil surface where the grass was rotting.
- The original soil beneath the sediment appeared unaffected
- The tree leaves were unaffected, but the fruit that had been submerged was soft and dropping
- The water table was 250 to >700 mm below the original soil surface

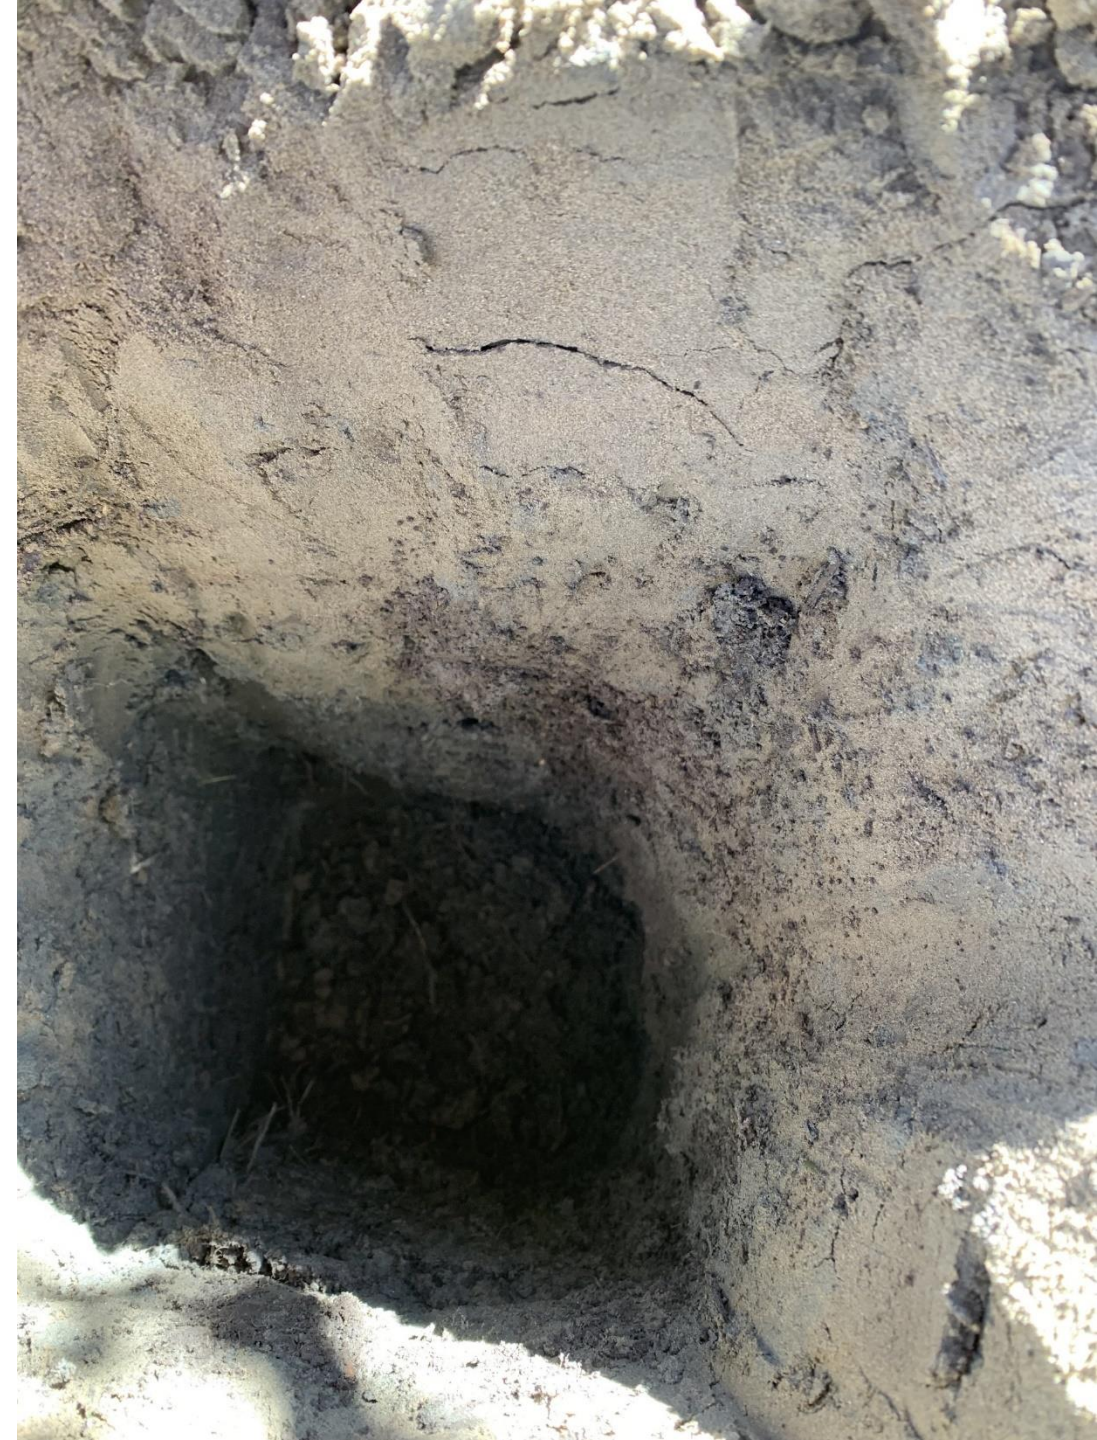
# Where the sediment was sandy

- The sediment had drained
- The original soil was gleyed in patches, beginning from the soil surface where roots and organic matter were decaying
- The leaves were healthy, but the fruit were soft and dropping

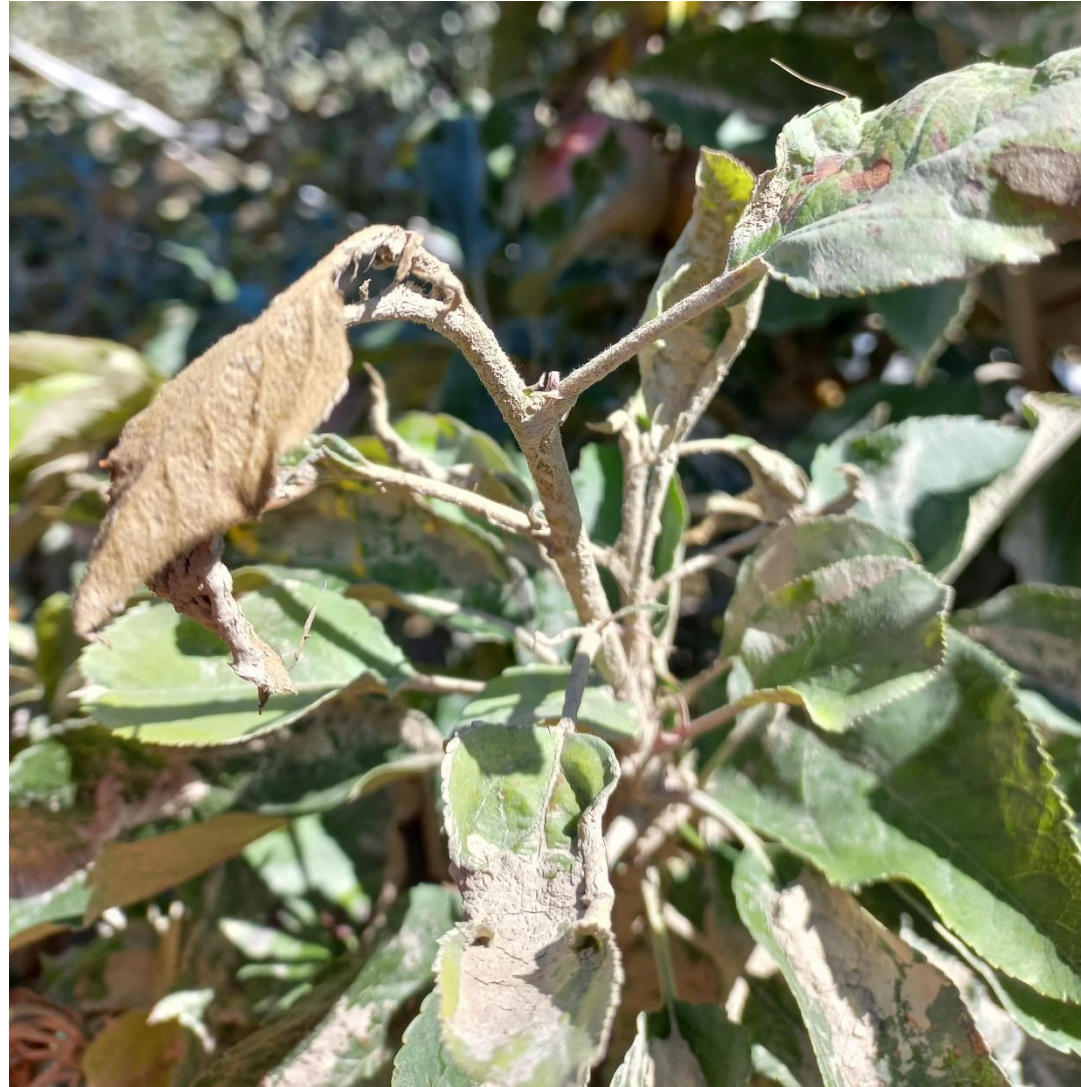
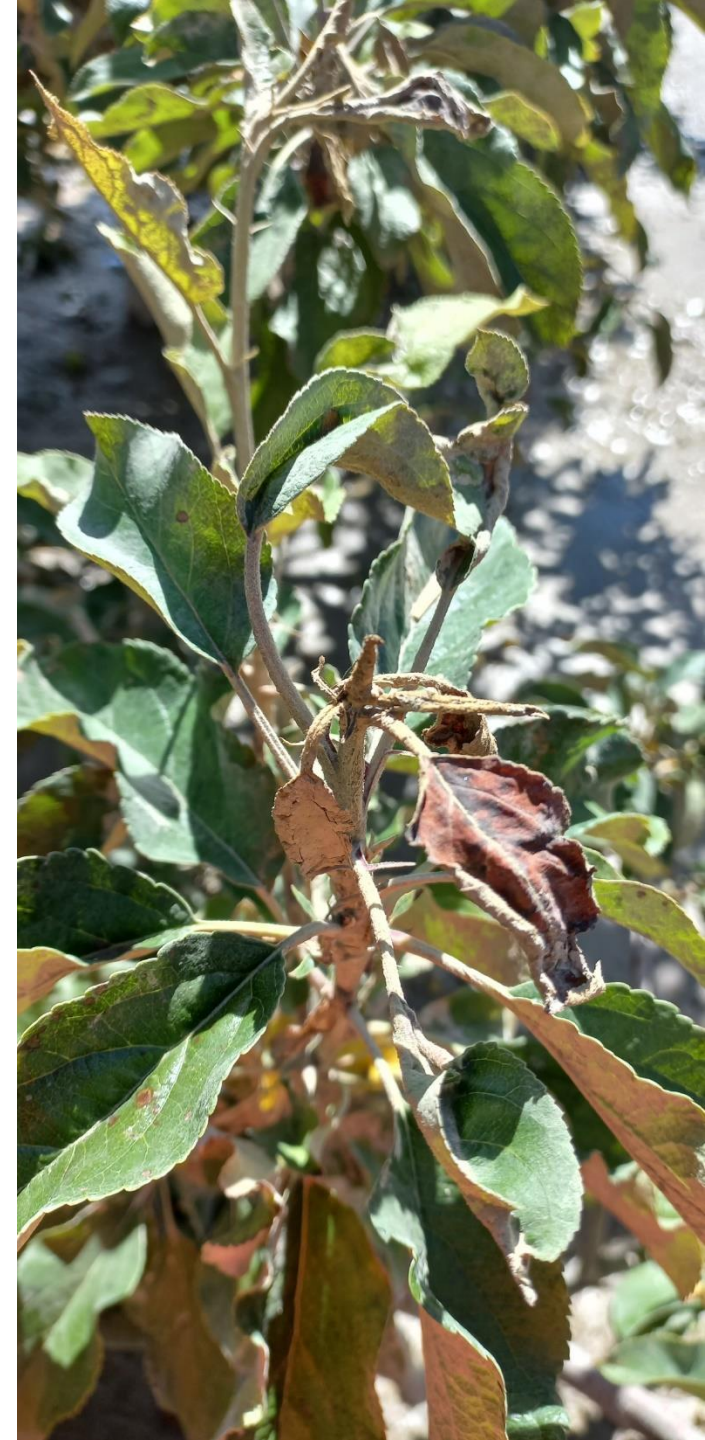
# Tip death at one orchard

- Leaf tips had died, but trees seemed otherwise okay at this point
